## Various Coupon Designs

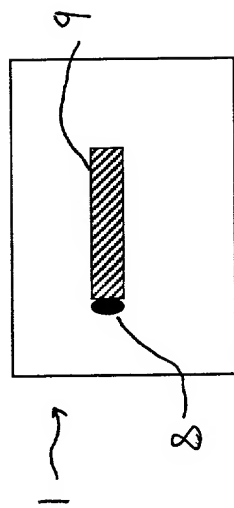
Fig 1(a). Rectangular disbondment with a holiday defect at one end

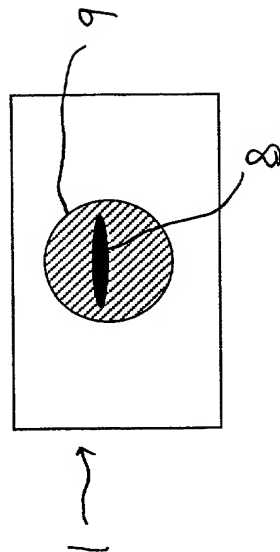
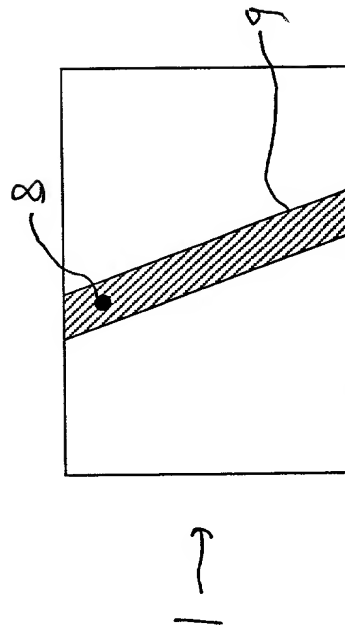
Fig. 1(b). A circular disbondment with a small gap and a crack in the middle

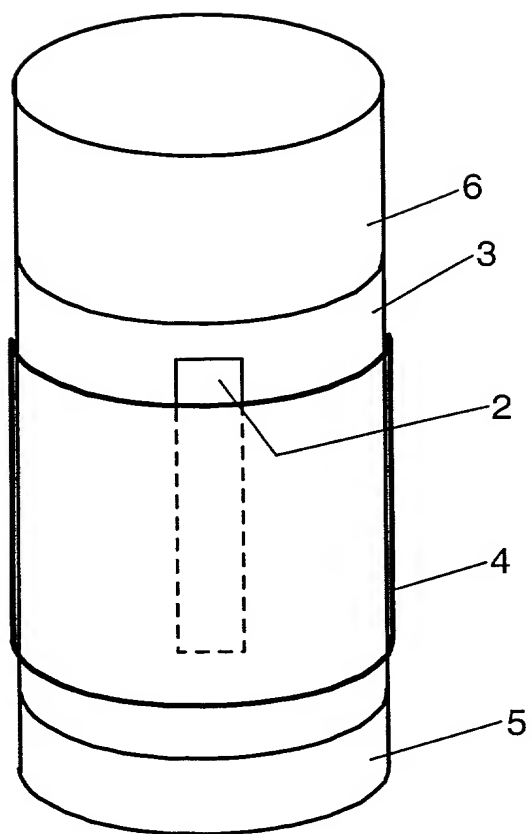
Fig 1©. Disbondment along overlap of a spirally wound tape coating and a holiday at one section

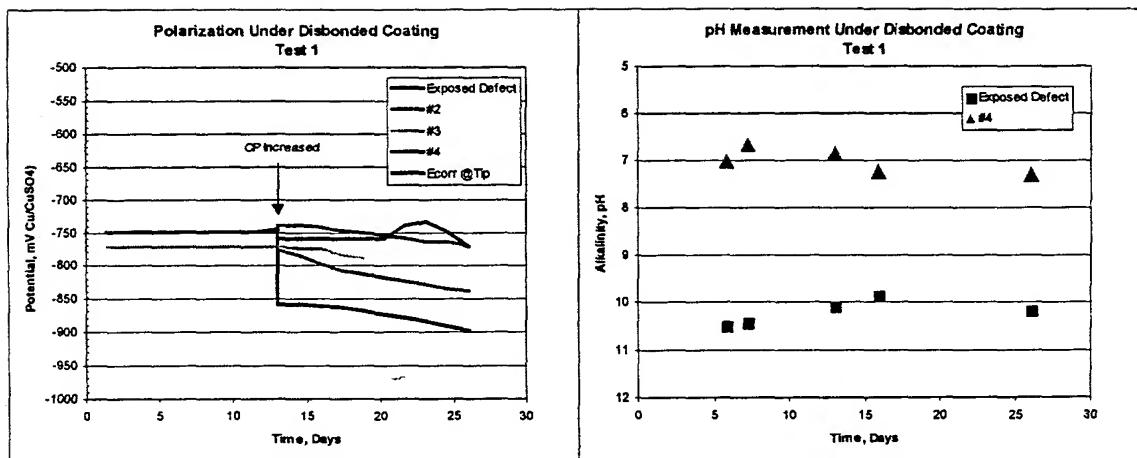
Figure 6. Test 1 polarization and pH data collected under a coating disbondment and adjacent exposed defect.

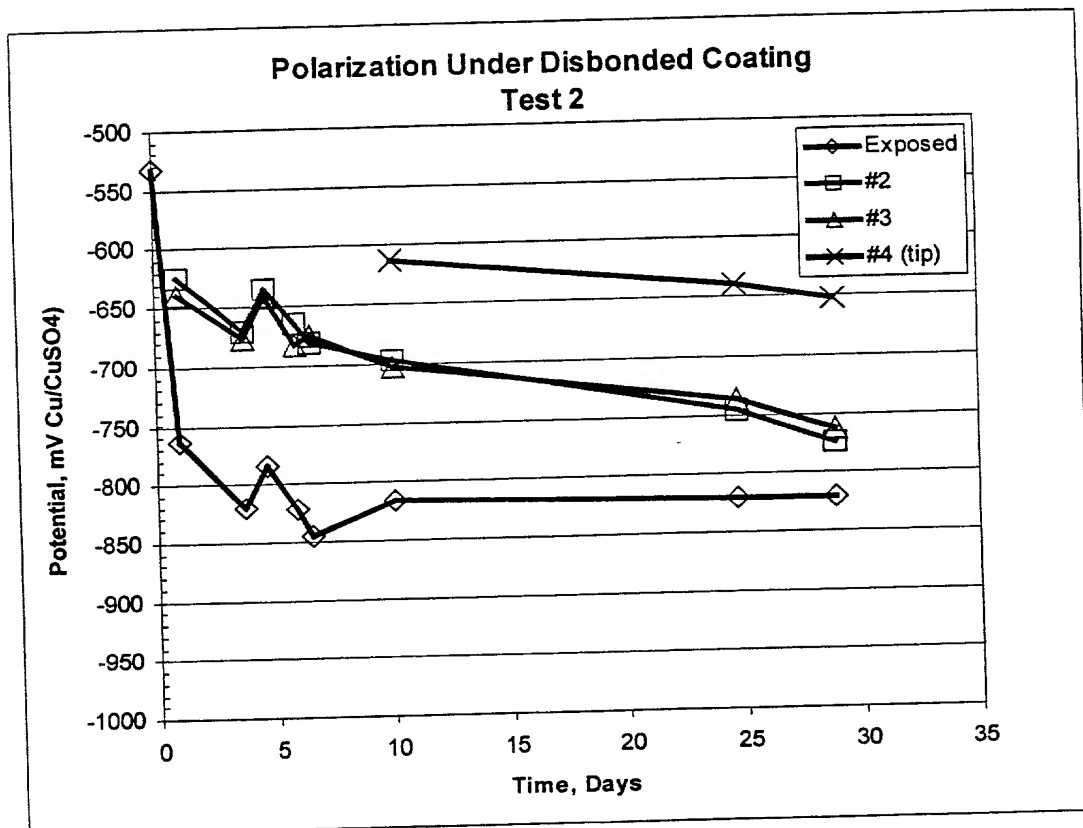
**Figure 7. Test 2 polarization data collected at an exposed defect and under an adjacent coating disbondment.**
